TECHNICAL REPORT ARCCB-TR-96028

EFFECT OF SHOT PEENING AND OVERLOAD RESIDUAL STRESSES ON EX35 MULTI-LUG BREECH FATIGUE LIFE

**S. L. LEE
M. SCAVULLO**

SEPTEMBER 1996

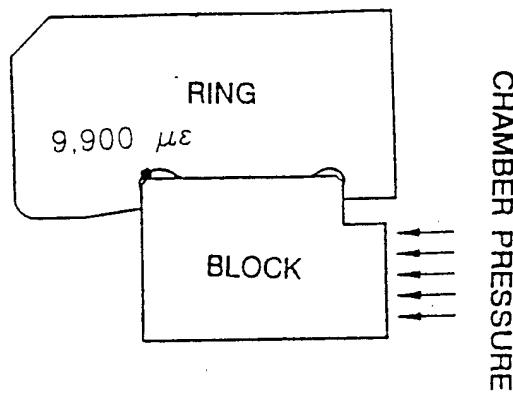
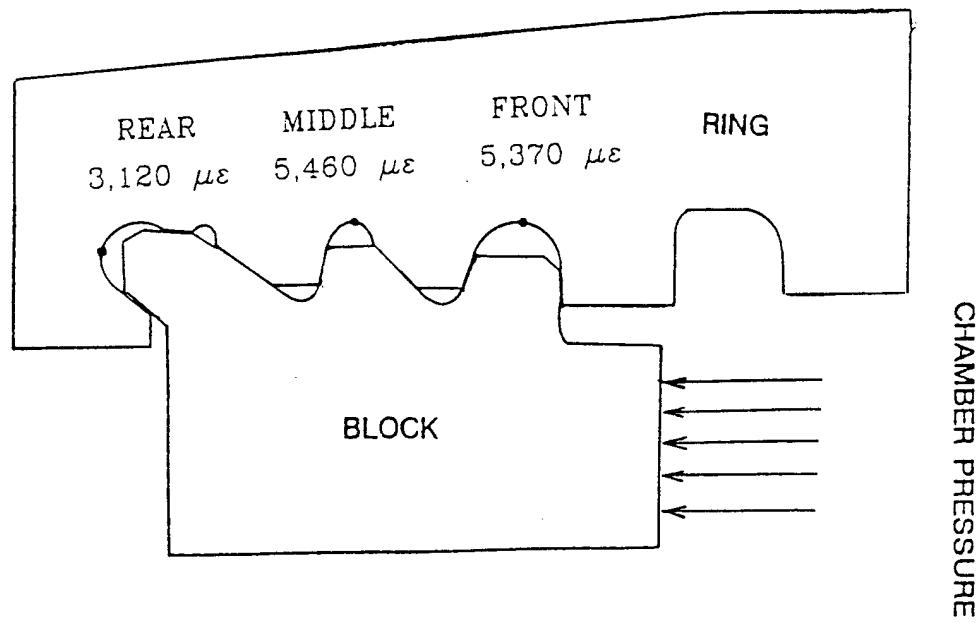
Figure 1 presents a schematic diagram of the multi-lug breech ring/block assembly compared with a conventional breech. When chamber pressure is applied, strain gages attached in the fillets of the multi-lug breech experience tensile strains. The measured hoop strains in the conventional breech fillets are larger than the hoop strains in the multi-lug breech.^[1] The approach to the multi-lug breech design emphasizes geometrical modification. Uniform pressure was applied to the breech block, which was transmitted to the breech ring through contacts at the fillets. The number of lugs, depth and geometry of the lugs, block/ring contact areas, contact interface angle, and distance between lugs were designed to diffuse stress concentrations and obtain optimized configuration of stress fields.

Figure 1. Cross-section of conventional breech and multi-lug breech showing direction of chamber pressure. (Note that the rear lug in the multi-lug breech consists of two components.)

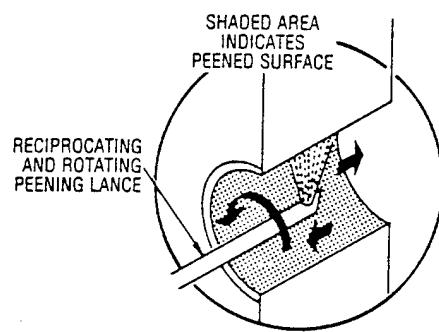
The multi-lug breech rings and blocks were shot peened by Hydro Honing Lab, East Hartford, CT, according to military specifications on shot peening.^[7] Cast shots S-330 (0.84 mm or 33 mil) were used. In order to obtain uniform residual stresses in the fillets of the multi-lug ring, inside diameter peening as shown in Figure 2 was performed with custom-made 1/4" nozzle and 45° peening angle; air pressure was 70-80 psi; nozzle rotation was 90 to 100 rpm; and nozzle oscillation was full length of part at 30" per minute. In the multi-lug breech ring, all non-shot surfaces were masked, except areas inside the three lugs.

Figure 2. Inside diameter shot peening technique applied to surfaces in the lugs of a multi-lug breech ring using a peening nozzle

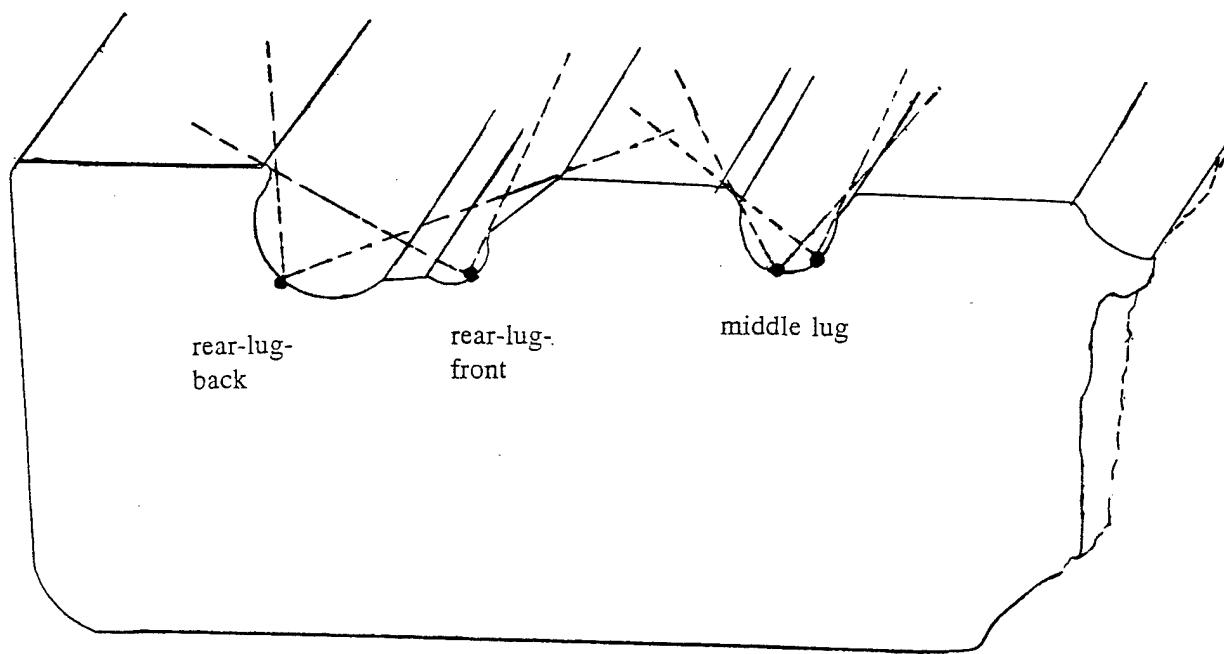
Two position-sensitive stress analyzers were used in this analysis: a multiple-exposure TEC stress analyzer and a Denver dual-detector single-exposure system with a reticon photodiode array, modified for multiple-exposure operation. As shown in Figure 4, shot peening residual stress analysis was performed in the vertical direction for accuracy. Angular range accessible to X-ray psi-angle rotation is shown as dotted lines where the X-ray beam spans the opening of the lugs. In cases where angles were severely limited, a horizontal cut at the upper edge of the lugs was necessary.

Figure 4. Example of X-ray residual stress analysis of the unaffected portion of a failed shot peened specimen, showing the angles accessible to X-ray radiation

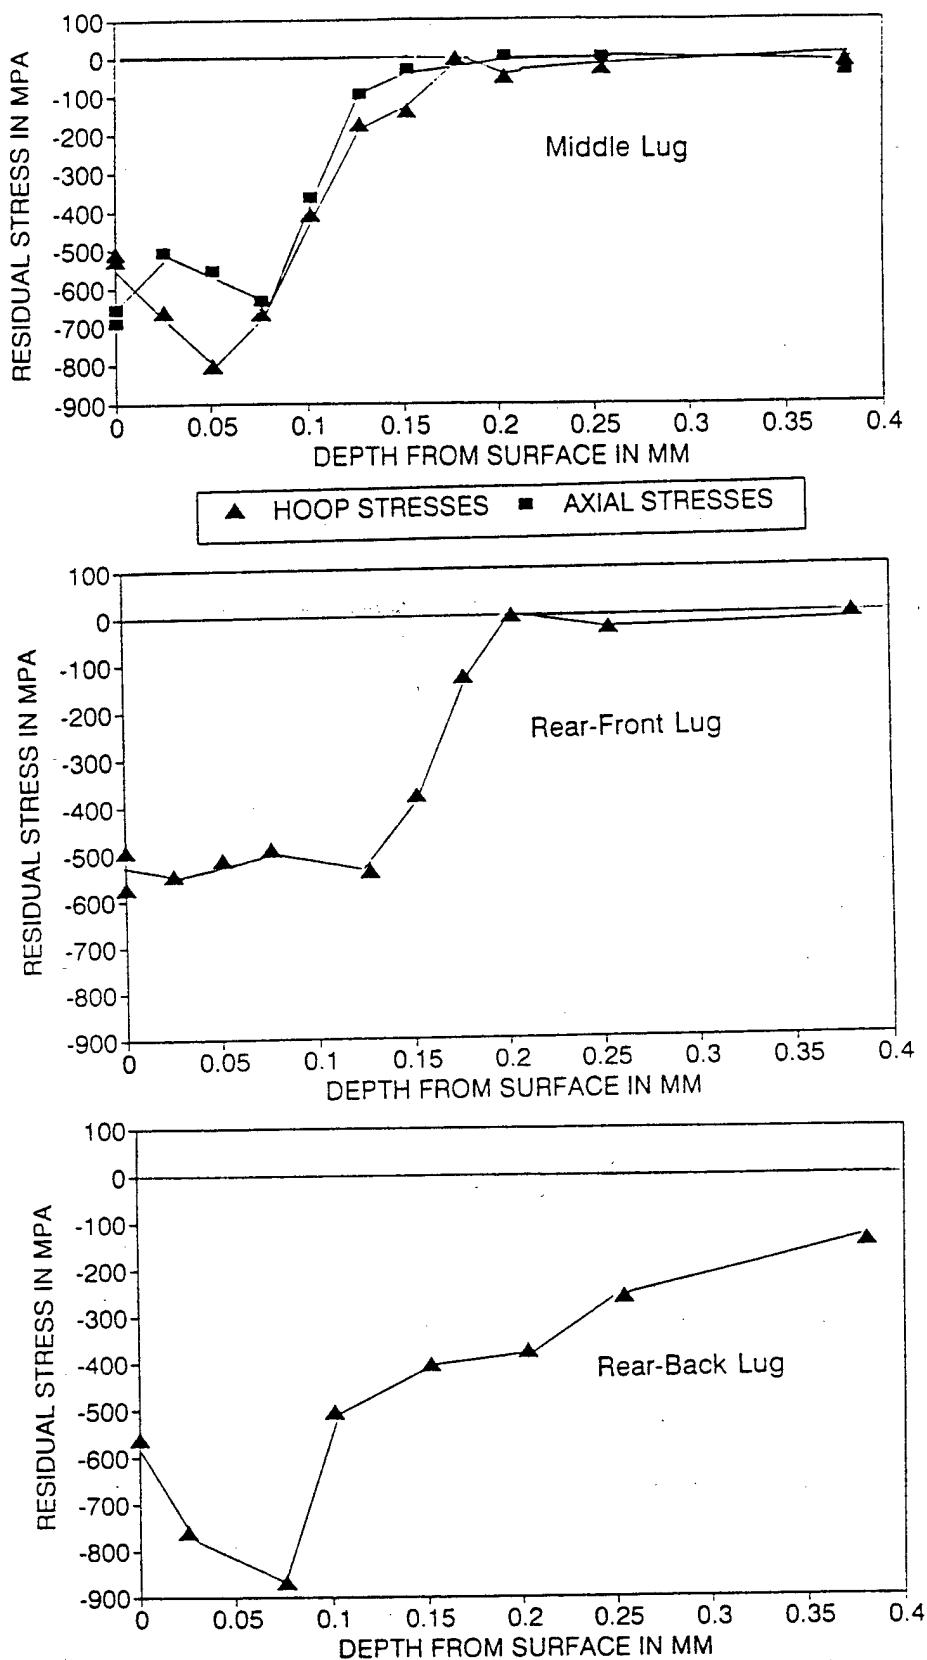
Table 3 gives residual stress distributions in the middle lug as a function of depth from the surface using the successive layer removal technique and TEC stress analyzer. The data are summarized in Figure 5. Due to the nature of the shot peening process, axial stress depth distribution in the middle lug is similar to hoop stress distribution. Hoop stresses in the rear-front lug and rear-back lug show similar magnitude and distribution. The shot peening process produces fairly uniform residual stress distribution. Shot peened breech #21, obtained from the intact portion of the arm opposite to the arm that failed, was made available only recently. Surface stress measurements were performed in the bottom of the front lug. The average stress was -92 Ksi (-644 MPa).

Figure 5. Shot peening residual stresses in the middle, rear-front, and rear-back lugs of a multi-lug breech ring as a function of depth from surface

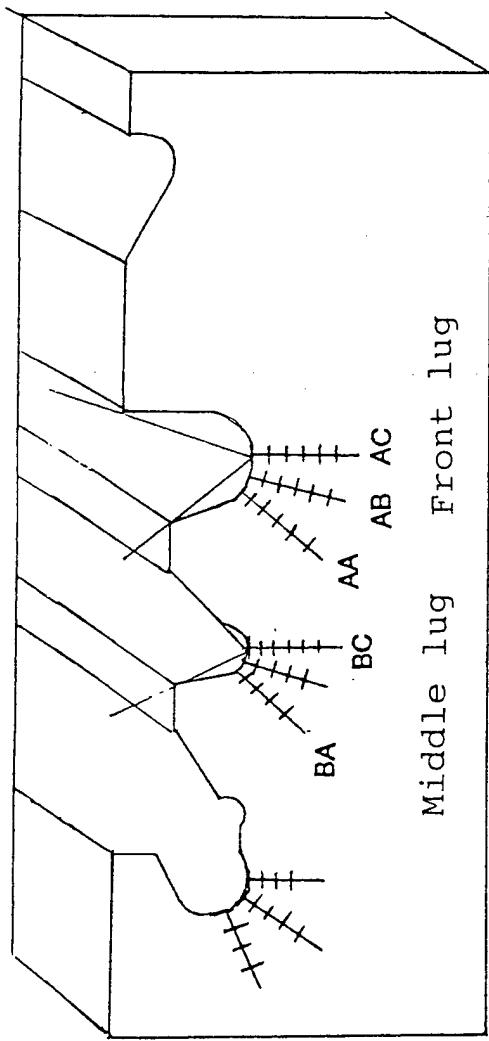
As shown in Figure 7, both vertical measurements of surface hoop residual stress in the lugs and horizontal measurements on the cross-section were performed for overload breech #23. The specimen was obtained from the intact portion of the arm opposite the failed arm. The cross-section surface was electropolished, and a 10 mil thickness was removed from the surface layer to avoid effects due to machine stresses, oxidation, corrosion, etc. In cross-section measurements, a hoop is defined as the direction parallel to the tangent at the lug surface. Directions AC and BC were perpendicular to the roots of the front and middle lugs. AA was in a direction perpendicular to the tangent at a point on the breech where the breech failed; AB was mid-point along the arc between AA and AC. BA in the middle lug was parallel to AA in the front lug.

Figure 7. Overload residual stress analysis in the lugs of a multi-lug breech ring

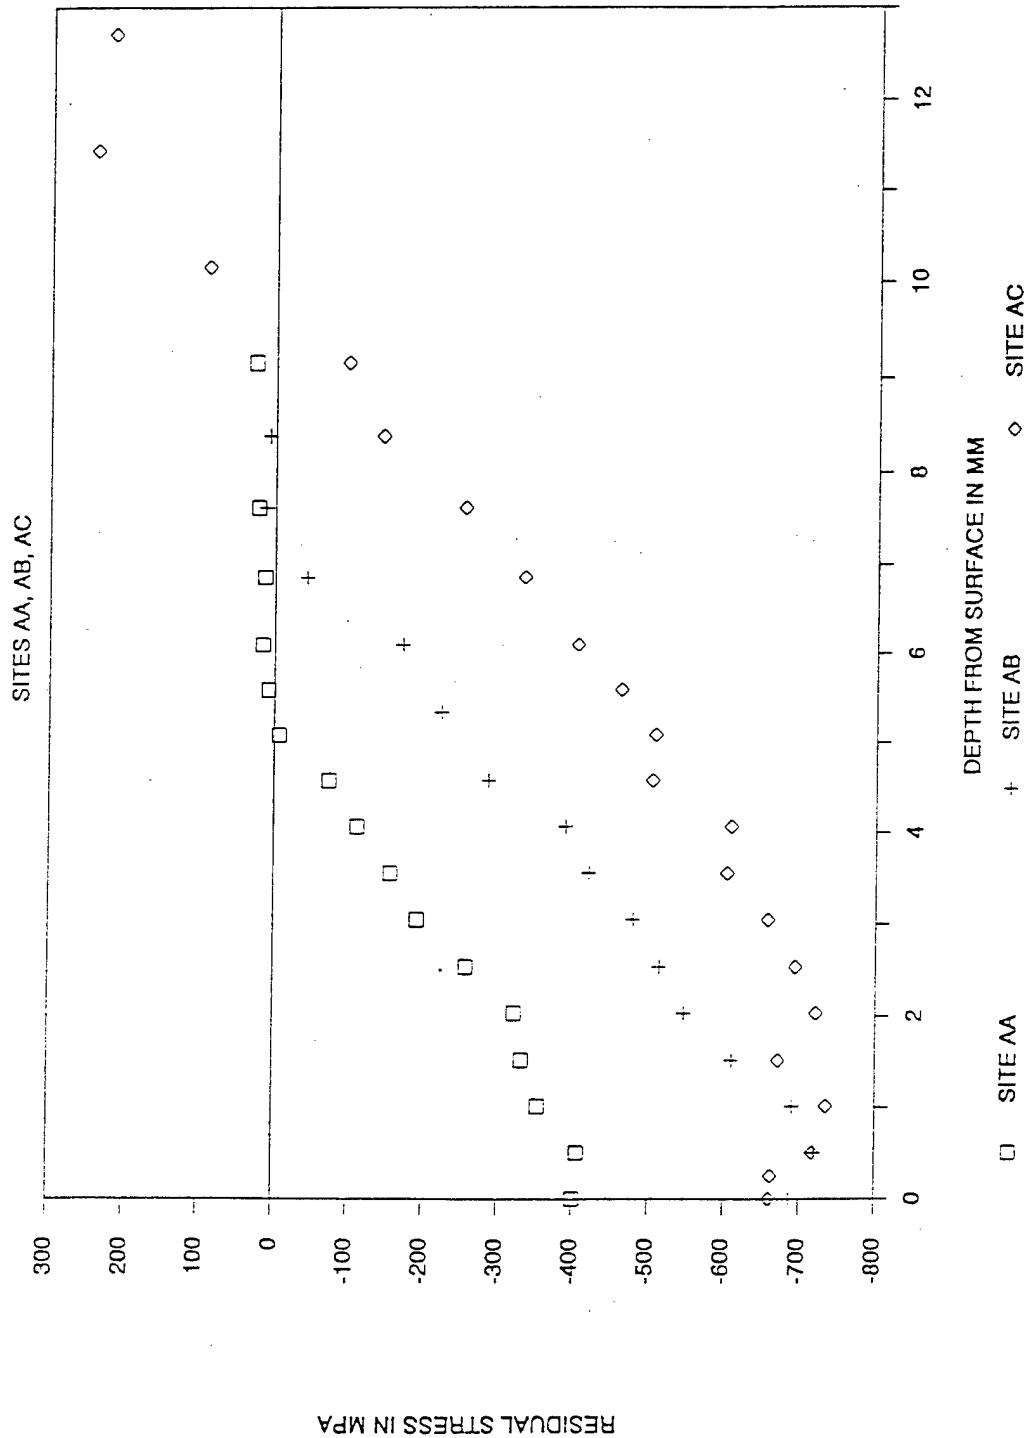
FRONT LUG OVERLOAD RESIDUAL STRESSES

Figure 8 gives the hoop stress distribution along directions AA, AB, and AC in the front lug. Maximum compressive stresses along AA, AB, and AC were -60, -100, and -110 ksi, respectively, which translate into -420, -700, and -770 MPa. The thicknesses of the yielded layers along AA, AB, and AC were 5 mm, 7 mm, and 1 cm. Figure 9 gives the hoop stress distribution along directions BA and BC of the middle lug. Maximum compressive stresses along BA and BC were -50 and -95 ksi (-350 and -665 MPa); the thicknesses of yielded layer were 2 mm and 4 mm.

In the front and middle lugs, the magnitude of the compressive residual stresses was highest near the bottom of the lugs, decreasing while moving up along the sides of the lugs. The thickness of the compressive layer was largest near the bottom of the lugs compared with the sides of the lugs.

Figure 8. Front lug overload hoop residual stresses as a function of depth from the surface

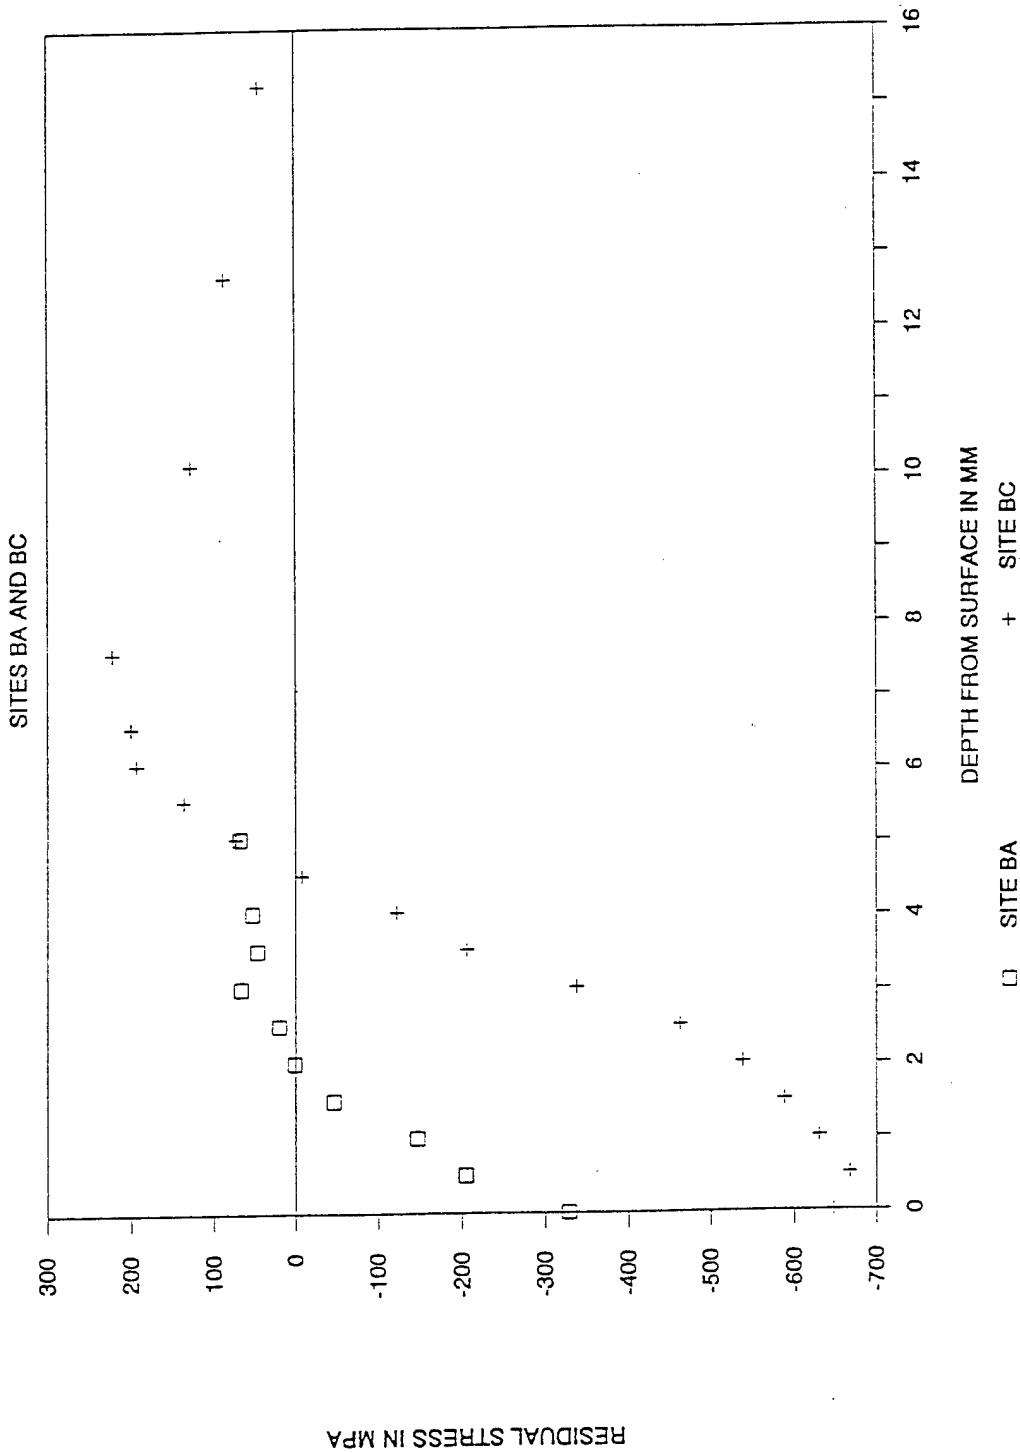
MIDDLE LUG OVERLOAD RESIDUAL STRESSES

Figure 9. Middle lug overload hoop residual stresses as a function of depth from the surface
